## REHABILITATION OF MALIN VILLAGE

### ABSTRACT

*The paper has been written to study techniques used to make rehabilitation of malin village safer for affected people to live. A great amount of problems were faced by villagers. It is very important to take a precaution to avoid such damage by such calamity from occurring again.*

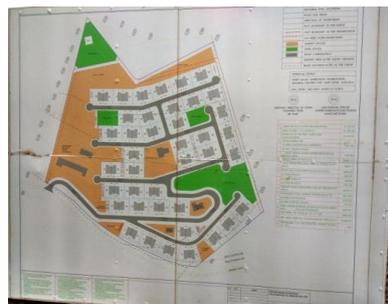
Fig2. Layout plan of rehabilitation of malin village project

Government has taken responsibility of rehabilitation. It took six month for selection of site that is Aamade village. Total area about 8.5 acre has been allotted. One unit of two houses is costing 15 lakh. It is one house 1BHK area of 450 sqft. To give relief to the victims and as well their relatives on urgent basis government promoted this project as a pilot project as today also in India there are so many places where such type of landslide may occur and government can give solution to them as per property of this project. The amenities provided here are school, hospital, grampanchyat, internal roads, and proper drains. The chosen site is close to malin village and forms one of the gaoathan areas and the villagers are keen on the site.

Since site selected i.e. Aamade is a hilly terrain area and no hard strata has been found there and has variations in levels. So we are trying to study the various new technology used in such site condition for rehabilitation of malin village.

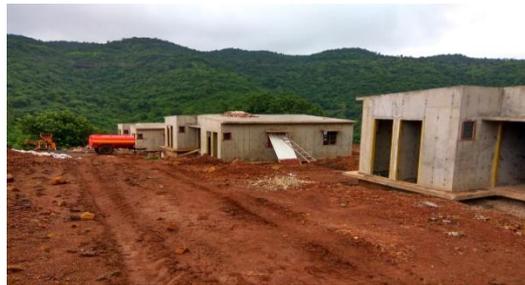
Fig.3 Rehabilitation Malin Village

On 29<sup>th</sup> July 2016 we visited the rehabilitation site with our guide prof. Pramod Thorat and their we met R. J. Walse sir who is contractor of the site. There we saw new concept of retaining wall been implemented with a height of 8m to 10m , strip foundation, aluminium formwork and big storm water drainage to collect rain water in heavy rainfall.

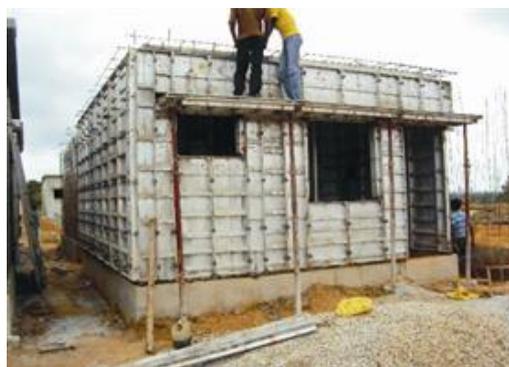
Fig.4 Mivan formwork

Generally aluminium formwork used for high rise building to reduce the slab cycle and its procurement cost is high so it is not economical to use in small residential project but in this project government wants to construct in more speed. So authorities ready to invest such huge amount to procure the same and implement on site. So it was possible to construct 67 houses with 2 years. COSMOS companies aluminium formwork has been used, it is a precession engineered formwork fabricated in aluminium. It is fast. Adopted, and cost effective. It produces total quality work which requires minimum maintenance and when durability is the prime consideration. In this system, cast-in-situ concrete wall and floor slabs cast monolithically provides the structural system in one pour. These forms are strong and sturdy, fabricated with accuracy and easy to handle. They can afford large number of repetition's this system is very unique as all the components in building, including slabs, beams, walls, column, staircase, balconies and special hood are of concrete and there is no need for block work or brick work it can be used for any type of concrete systems, that is for framed structure. Involving column, beam slab elements or for box type structure involving slab walls combination.

- Total system forms the complete concrete structure
- Custom design to suite project
- Unsurpassed concrete speed

- High quality finish
- Cost effective
- Panels can be reused up to 250 times
- Erected using unskilled labour
- Earthquake resistance of resulting structure increases manifold
- Carpet area will increase

- Visible finishing lines on concrete surface
- Require uniform planning as well as uniform elevation to be cost effective
- Modifications are not possible as all members are cast-in-situ.
- Large volume of work is necessary to be cost effective i.e. at least 200 repetitions of the forms should be possible at work.
- Honeycombing is possible
- Reinforcement will be congested in the lower floor up to 4<sup>th</sup> floor thus maximum slump (200 mm) is required, so cement content will be increased.
- The formwork requires number of spacer; wall ties etc. which are placed at 2ft centre to centre these create problems such as seepage, leakage during monsoon.
- Shrinkage cracks are likely to appear
- Heat of hydration is high due to shear walls

- Number of holes will be more in the vertical wall, outer wall which is in direct contact with the rain, hole should be grouted by non-shrink compound
- It is possible to minimize the cracks by providing control strips in the structure which could be concreted after a delay of about 3 to 7 days after major concreting.
- Heat of hydration can be reduced by using fly ash.

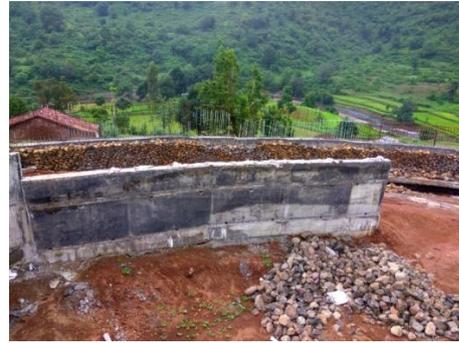
Fig.6 Counter head Retaining wall with filter media

The selected site for construction of city is totally sloping terrain and level difference in terrain is around 35m, instead of levelling of terrain, it is proposed to construct houses at different 5 levels as shown in fig4. On sloping terrain itself by constructing retaining wall to retain a soil of height 8 to 10m. The retaining wall with 8 to 10m is built with bracket on the hill side. SBC of the strata is 20 T/m<sup>2</sup> and internal friction is 30 degree. Filter media is provided which consist of dry rocks. Filter media has dual purpose here firstly it acts as a udl to avoid uplifting and also helps in filtration if rain water the purpose of providing bracket is balancing the load. Grade of concrete used is M15 and M20.

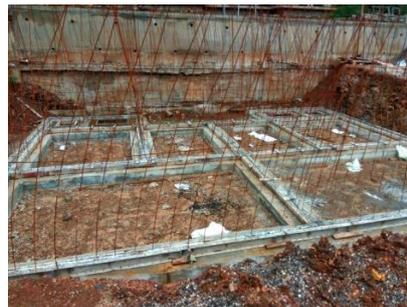
Fig.7 Strip Footing

Since the soil strata available on site location is totally clayey and also after excavation no hard strata has been found so strip foundation has been selected and on same foundation super structure is also cast monolithically to avoid disturbance in super structure during any type of natural calamity.

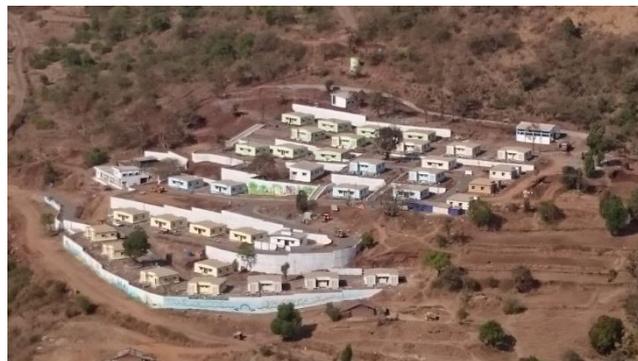
Fig.8 Progress of rehabilitation work of malin village

To construct the township on the hilly terrain real Civil Engineering gets involved and they have innovated different types of foundation rather than regularly utilized. The houses constructed are 100 per cent R.C.C. structure to avoid destruction due to natural calamity like earthquake, flood and settlement due to natural soil strata. Using all above construction techniques the progress of rehabilitation of malin village project is as shown in Fig.8.
