## **Retrofitting of RCC Apartment Building –A Case Study**

##### **Type of structure: - G+4 Storied R.C.C. framed structure**

- Location: - Mauli Krupa chambers, plot no 19 sector, Airoli, New Mumbai

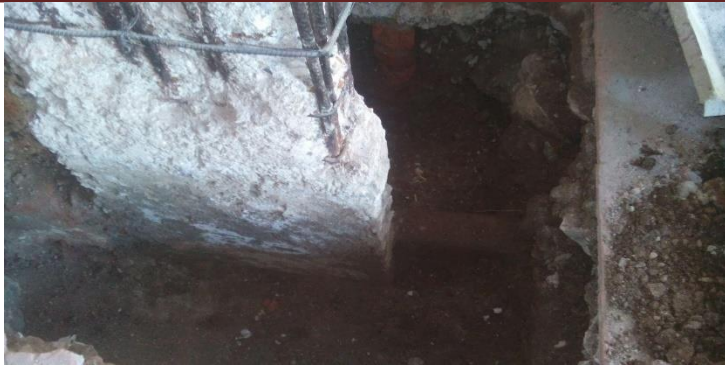
Photo. Excavation around the footing

**Step1]** Excavating around the footing.

**Step2]** Cleaning and roughening the concrete surface.

**Step3]** Installing dowels at 25-40cm spacing in both directions using an appropriate epoxy material.

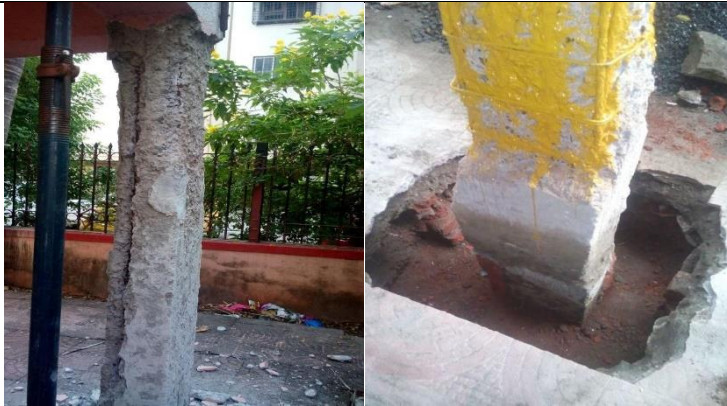
Photo. Column support by Jack

Photo. Column bars paint epoxy material (a)

**Step3]** Coating the steel bars with an epoxy material that would prevent corrosion.

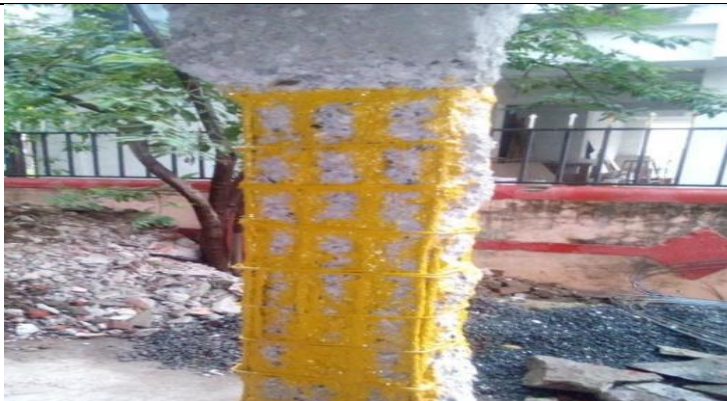
Photo. Column bars paint epoxy material (b)

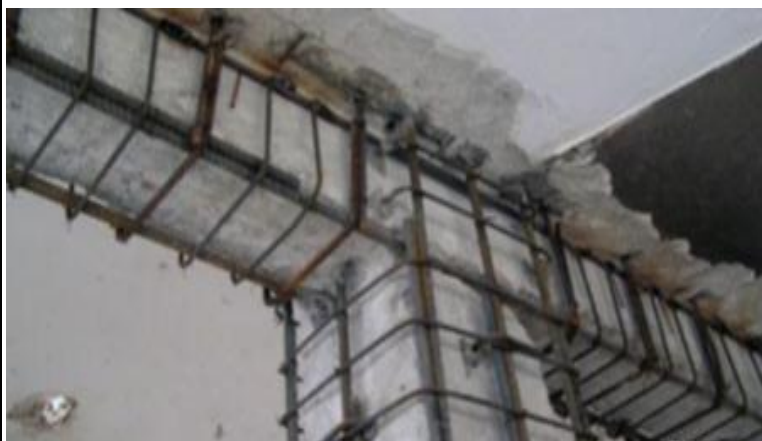
Photo. Strengthening of beam

**Step1]** Removing the concrete covers, roughing the beam surface, cleaning the reinforced steel bars and coating them with an appropriate material that would prevent corrosion.

**Step2]** Making holes in the whole span and width of the beam under the slab at 15-25cm.

**Step3]** Filling the holes with cement mortar with poor viscosity and installing steel connectors for fastening the new stirrups.

**Step4]** Installing the steel connectors into the column in order to fasten the steel bars added to the beam.

**Step5]** Closing the added stirrups using steel wires and the new steel is installed into these stirrups.

**Step6]** Coating the concrete surface with an appropriate epoxy material that would guarantee the bond between the old and new concrete, exactly before pouring the concrete.

**Step7]** Pouring the concrete jackets using low shrinkage concrete.
